In this Part 1B presentation, the test Observations and Results will be briefly described.

The presentation will cover the Preliminary Edge-Restraint Test, as well as the SSOW, DSOW and TW test series.

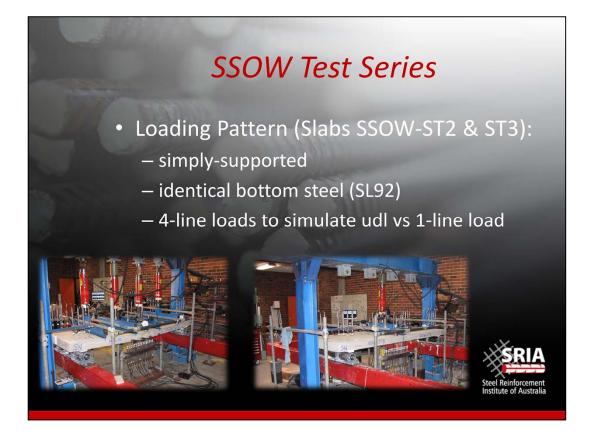
All of the rest of the SSOW slabs were tested in the simply-supported condition.

The two slabs SSOW-ST2 and ST3, seen under test in the two photographs, were nominally identical with SL92 bottom mesh that had very similar average tensile properties.

The primary difference between the two tests was the way the slabs were loaded, either with 4 line loads or with one at mid-span.

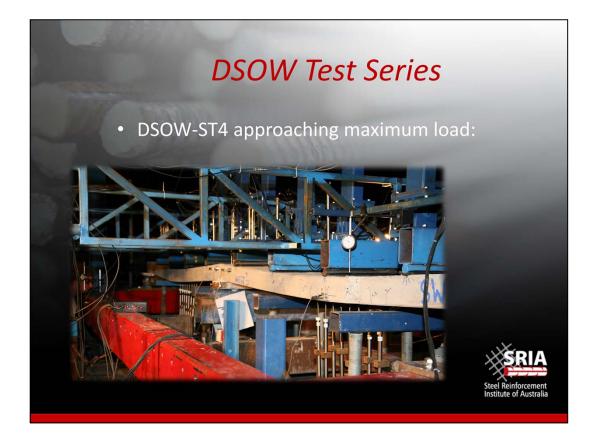
This photograph shows the deflected shape of the slab with the unrestrained ends approaching maximum load before the mesh fractured over the central support.

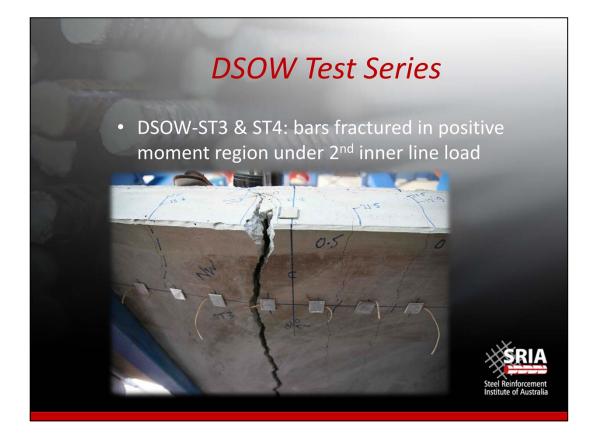
This shows how the positive moment regions of both DSOW-ST3 and ST4 both failed with bar fracture.

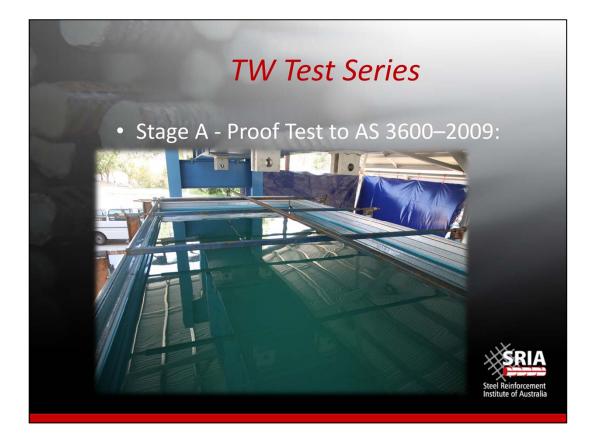
This shows 1.6 metres of water applied to the two-way slab during the final stage of the strength proof test to AS 3600–2009.

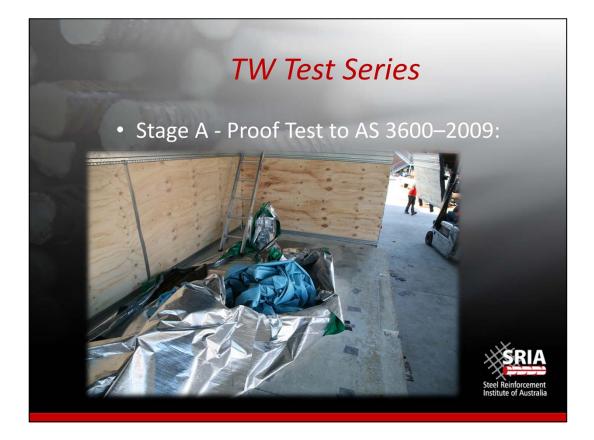
Finally the walls and tank liner were removed to expose the top surface of the slab. Careful examination did not reveal any surface cracks on the slab top face or soffit. It was concluded that the slab was uncracked, despite having supported its factored design ultimate load determined using the design bending moments from Clause 6.10 of AS 3600–2009.

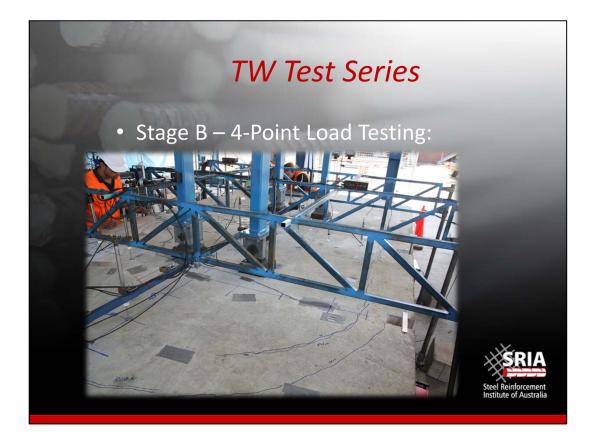
While loading the slab using the four hydraulic jacks, yield-line patterns were marked out on the top and bottom faces of the slab.

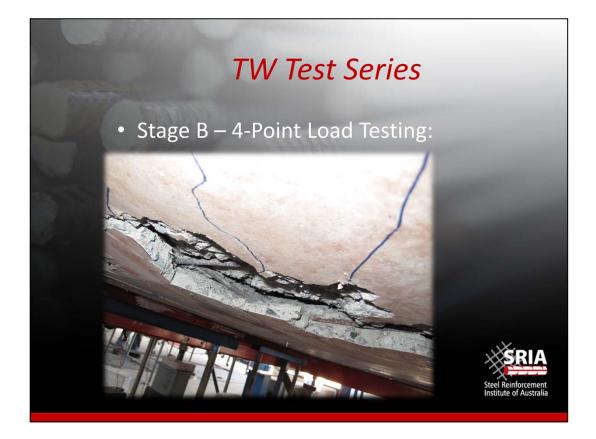
Underneath the slab some of the mesh bars had broken, and it is apparent that bar fracture triggered the subsequent, secondary punch-through failure.
